# Manhole Inspection Summary

Manhole # S35II1010MH

**Location** Address: **4007 HIGHFIELD RD**

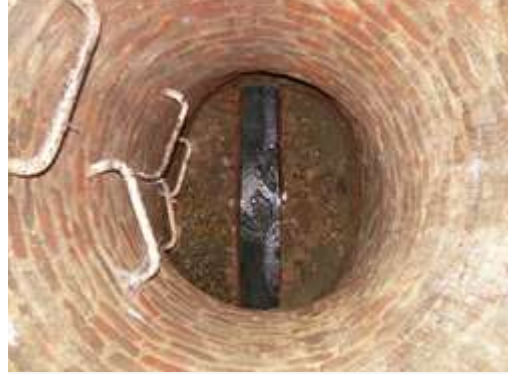
Top View

Corroded steps. Evidence of surcharge - Bench debris. Channel debris.

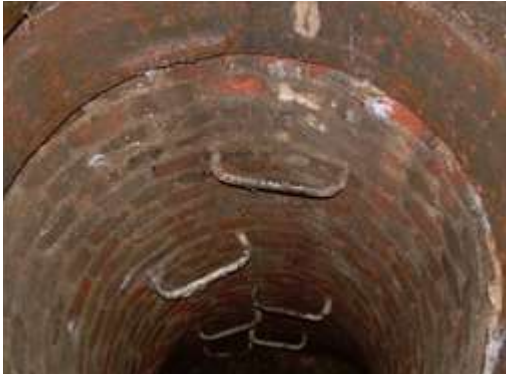
Defect

Adjustment deterioration and infiltration. Corbel and Barrel infiltration.

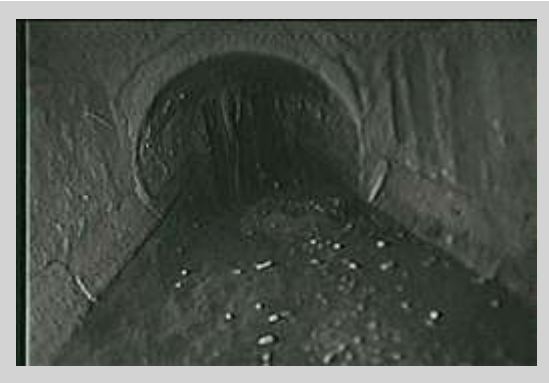
### 8 in. Circular Gravity Sewer Pipe Out @ 12 O'Clock

Pipe Material: **Clay** ☐ Pipe Lined

Invert Depth: **10.59** (ft.) Flow Characteristics: **None**

Deposits: ☐ None ☒ **Mud** ☐ Sludge ☐ **Debris** ☐ Grease

Silt Depth: **0** (in.) Deposits Extent: **Light**

Infiltration: **None** Pipe Seal Cond: **Unknown**

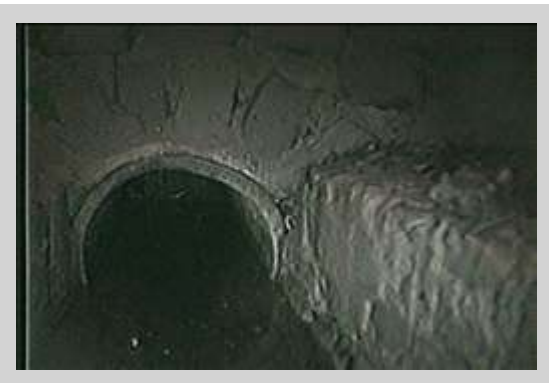
### 8 in. Circular Gravity Sewer Pipe In @ 6 O'Clock

Pipe Material: **Clay** ☐ Pipe Lined

Invert Depth: **10.47** (ft.) Flow Characteristics: **None**

Deposits: ☐ None ☒ **Mud** ☐ Sludge ☒ **Debris** ☐ Grease

Silt Depth: **1** (in.) Deposits Extent: **Light**

Infiltration: **Evidence** Pipe Seal Cond: **Unknown**
